Journal of the
National
Academy OF
Forensic
Engineers[®]

Vol. 40 No. 1 June 2023

Forensic Examination of Post-Fire Damaged Electrical Conductors by Using X-Ray Radiographs

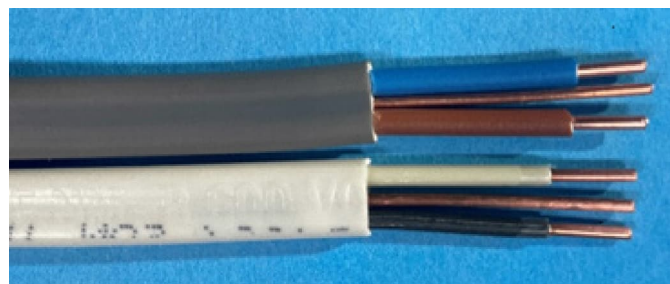
Figure 3

Non-metallic electrical cabling (UK and North America).

Examples of electrical equipment examined during an electrical survey and arcing fault evaluation may include (in part): electrical service equipment, electrical distribution panels (**Figure 2**), overcurrent protective devices, electrical feeders, branch circuits, appliances, luminaires, wiring, cables (**Figure 3**), and cords.

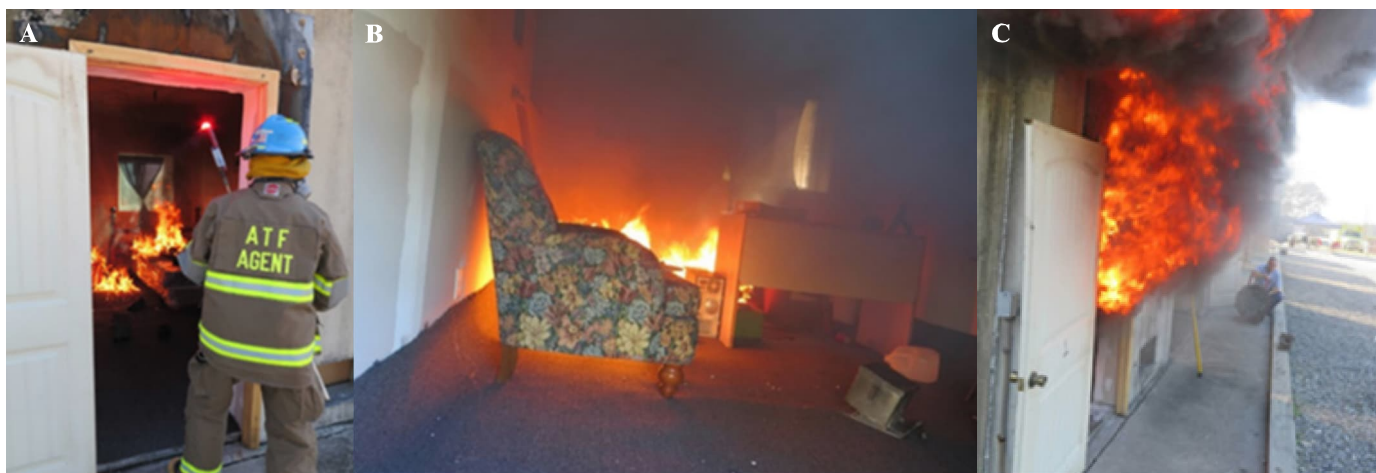
Figure 13

(A) Full-scale compartment fire testing at FLETC, (B) interior view of fire, and (C) post-flashover fire extending outside of compartment²⁶.

A total of 63 full-scale compartment fires were conducted at the United States’ Federal Law Enforcement, ATF fire training center (FLETC) located in Brunswick,

Georgia (**Figure 13**). The electrical distribution system under these tests was a 120/240VAC, single-phase, 15A electrical circuit. The available fault current at the point of fire impingement was calculated to be 210.9A.

Six #14 AWG (1.6 mm) diameter, NM copper electrical circuits (four energized at 120VAC, overcurrent protected at 15A and two non-energized electrical circuits) were installed at the ceiling level of each compartment. A fire was independently initiated by ATF personnel within each compartment. Each fire was allowed to develop based on controlled compartment fuel and ventilation characteristics that were determined by the ATF training parameters.

In total, 87.3% of the full-scale experiments went to post-flashover conditions. Electrical data in the form of voltage and short-circuit fault currents were recorded for future analysis. Although fire had reached post flashover conditions, only artifacts of arc melting were generated during the full-scale, FLETC burn cell experiments. However, additional arc melting, fire melting, and mechanical damaged artifacts were generated during a series of scaled fire impingement and non-fire experiments.
